DAVE GROOTERS

123 Sample Street
DEMO CITY, ST 12345

4/02/2026 10:33AM

Skyline Home Inspections LLC

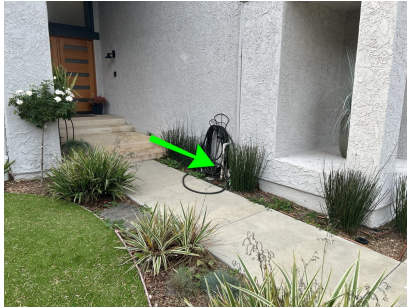
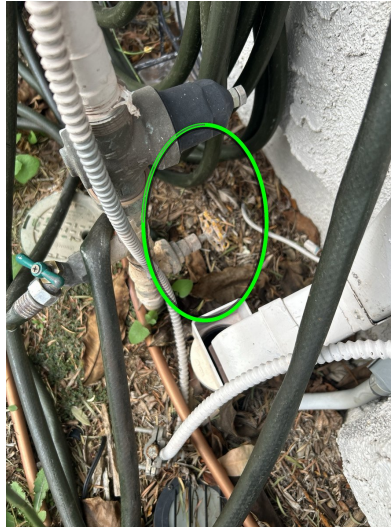
2.2.1 Water Service Shutoff

Location: Front

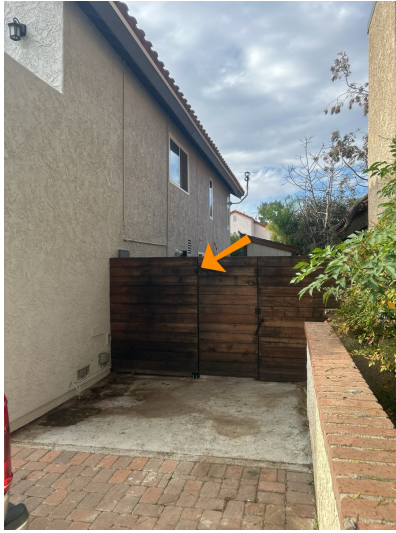
The gate did not latch properly at the time of the inspection – this condition may reduce security and functionality – I recommend further evaluation and any necessary corrective action by a qualified fencing contractor as desired

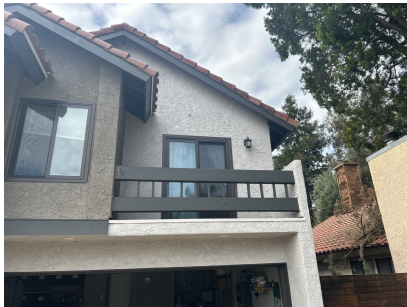
Horizontal balcony guardrail components made the guardrail assembly climbable – this condition may pose a safety hazard to small children – I recommend correction by a qualified carpenter or general contractor to modify the guardrail and improve safety

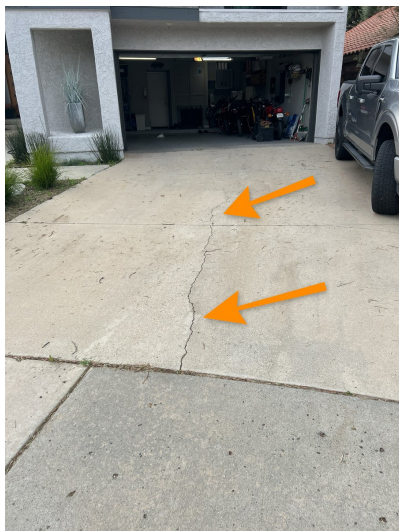
2.5.1 Irregular Minor Cracks

An irregular crack was present in the driveway slab – this condition did not appear to affect the integrity of the driveway at the time of inspection but may allow water intrusion and contribute to trip hazards or further cracking over time.

I recommend evaluation and any necessary corrective action be performed by a qualified concrete contractor

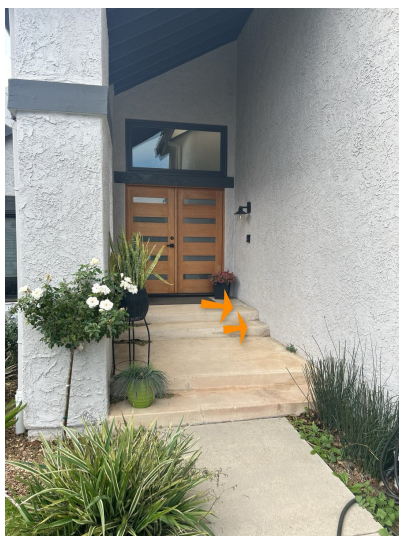
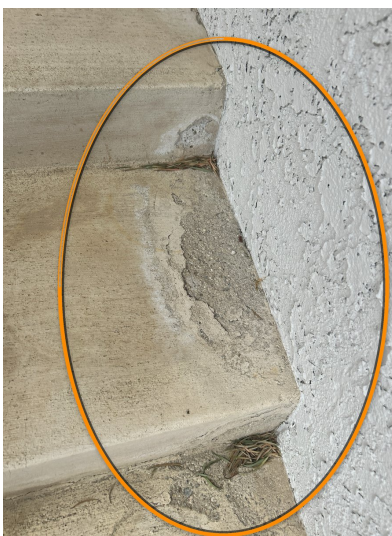
2.6.1 Spalling and Efflorescence

Concrete spalling and efflorescence was present in areas of the flatwork – this condition is typically caused by moisture migrating through the material and depositing salts on the surface – while often cosmetic, it may indicate elevated moisture levels – I recommend monitoring and addressing any contributing moisture sources as needed

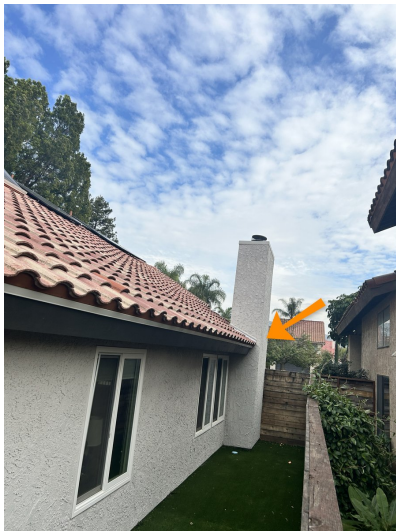
There was no kickout flashing installed where walls extended past roof edges – this condition may allow moisture intrusion, potentially leading to water damage – I recommend consulting a qualified roofing contractor to discuss options and costs for kickout flashing installation

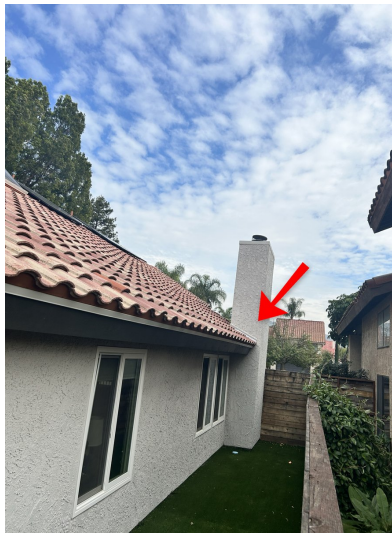
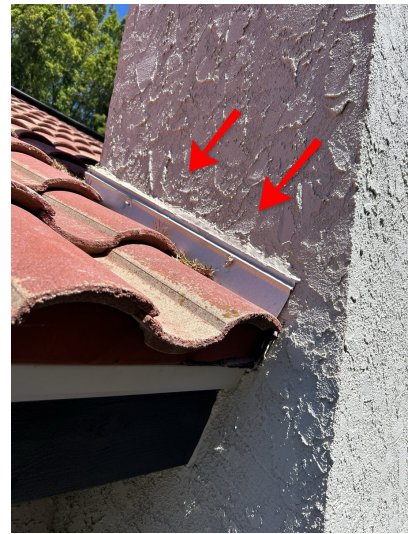
3.2.2 Missing Counterflashing

Flashing at the roof structure was not protected by counterflashing or properly installed under the siding – this condition may allow moisture intrusion behind the flashing, potentially causing damage to materials or the roof structure – I recommend installing counterflashing or properly securing it behind the siding by a qualified roofing contractor

Location: South

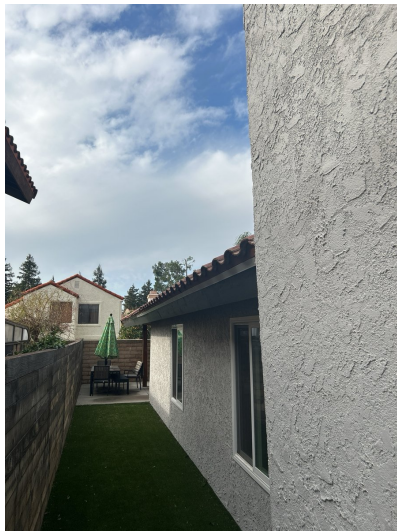
Only portions of the roof were equipped with gutters and downspouts – a full gutter system helps direct rainwater away from the home, reducing the risk of water damage to the foundation, exterior walls, and landscaping – inadequate drainage can also lead to moisture intrusion, erosion, or pooling near the structure – while this is not a defect, I recommend consulting a qualified contractor to evaluate and install a complete gutter system to better protect the home and its occupants

Location: South North

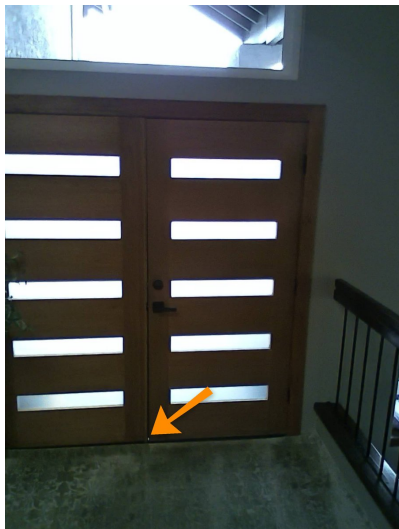
4.2.1 Missing Weatherstripping

One or more exterior doors were missing weatherstripping – this condition may allow air drafts, moisture intrusion, or pest entry – I recommend having a qualified door contractor evaluate and install weatherstripping as needed for improved sealing and efficiency

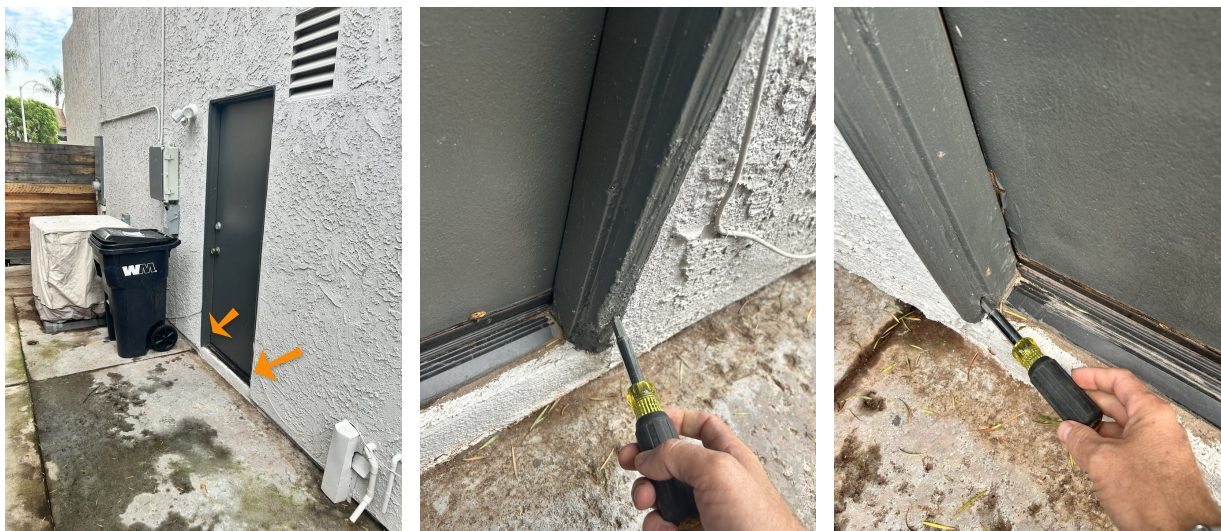
4.2.2 Deteriorated Wood

The wood on the exterior door was deteriorated at the time of inspection – this condition may affect the door’s structural integrity, appearance, and weatherproofing – I recommend having a qualified door contractor evaluate the damage and perform any necessary repairs or replacement

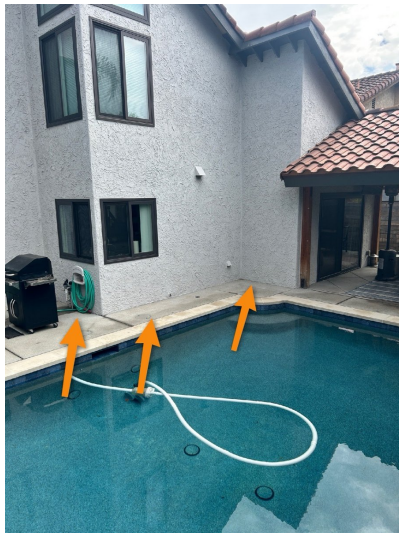
Stucco covering the exterior walls had inadequate clearance from grade – this condition may allow moisture to wick into the stucco, potentially resulting in staining, delamination, or deterioration of the lower wall areas. Stucco should have 2 inches of clearance to a hard surface. – I recommend having a qualified stucco contractor evaluate and adjust the clearance if feasible to help reduce the risk of moisture-related damage

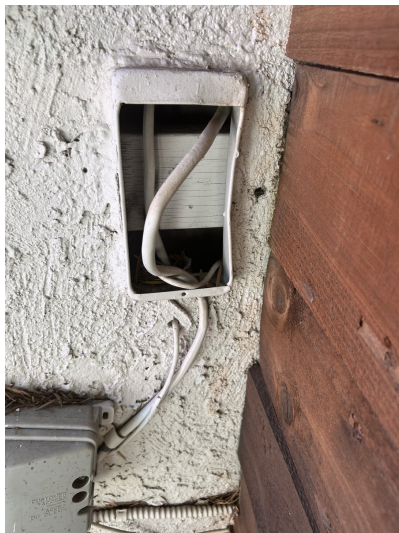
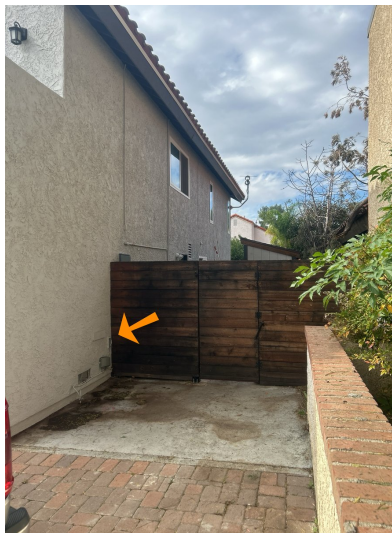
4.4.2 Coaxial Cable J-Box Missing Cover

A coaxial cable junction box was missing its cover – this condition may allow moisture intrusion, which can lead to material deterioration or structural damage – I recommend correction by a qualified contractor

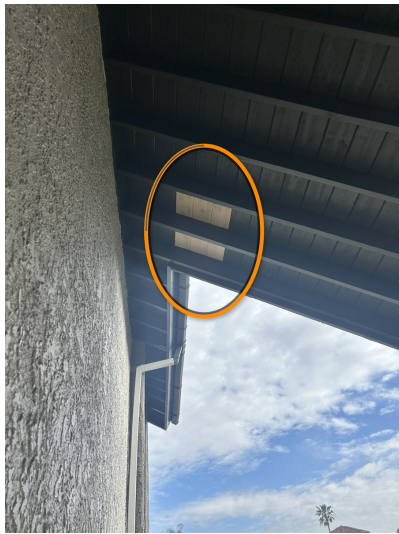
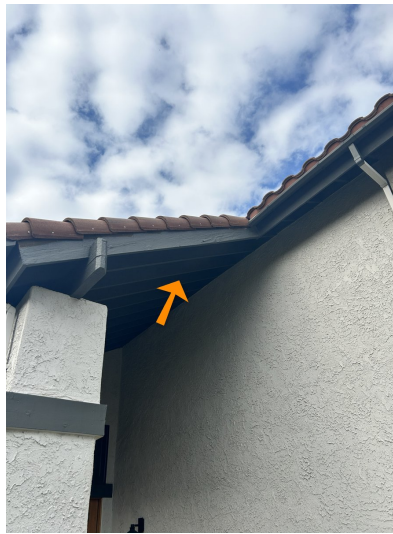
Exposed wood surfaces were observed in one or more areas – this condition may lead to wood decay and deterioration if not properly sealed or painted – I recommend further evaluation and any necessary corrective action be performed by a qualified painting contractor

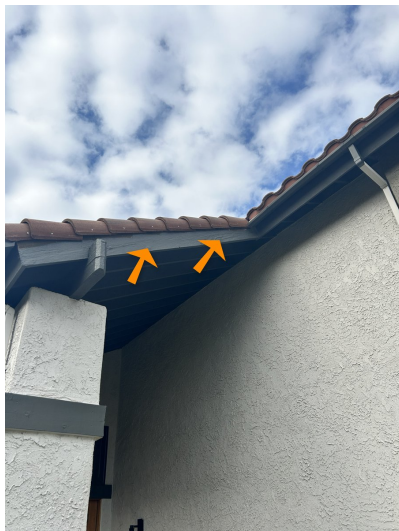
4.5.2 Blistered Paint

Blistered paint was present at the eaves and fascia – this condition may expose the underlying wood to moisture and lead to premature deterioration – I recommend scraping, priming, and repainting by a qualified painting contractor

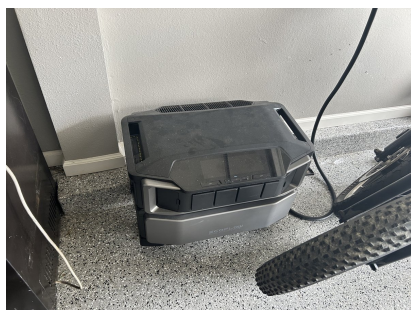
5.1.7 Backup Battery Present

A backup battery is outside of the scope of this inspection and usually installed congruently with the solar system.

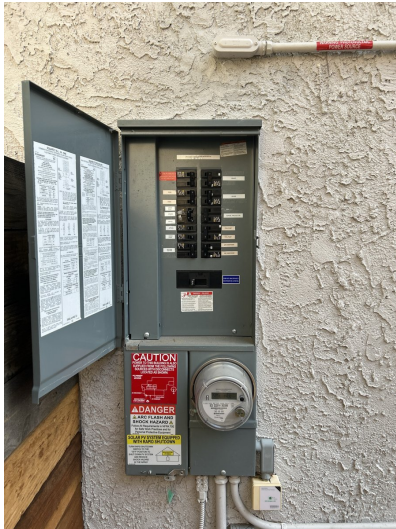
Location: North

5.2.1 Main Electrical Panel

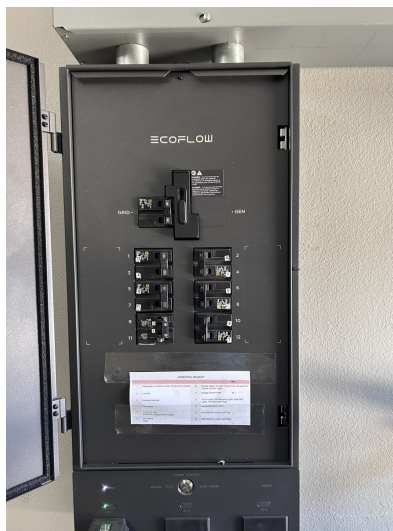
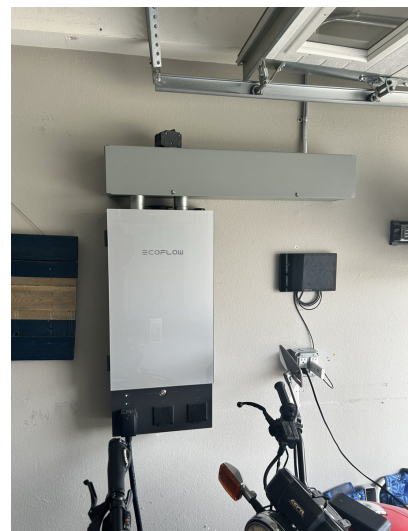
5.3.1 Location: Garage

5.3.2 Amp Service Rating: 80 AMP

5.3.3 Panel Manufacturer: ECOFLOW

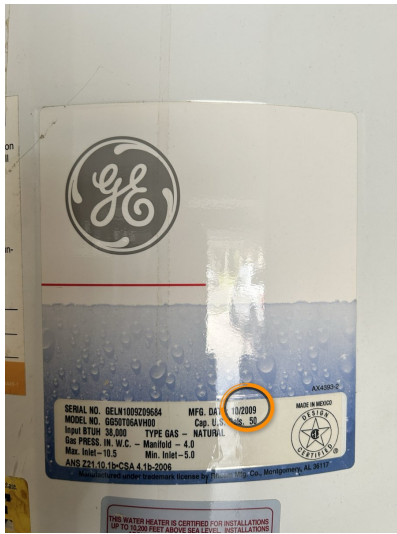
This water heater appeared to be past its design life – this condition may lead to decreased efficiency or unexpected failure – I recommend further evaluation and replacement as needed by a qualified plumbing contractor

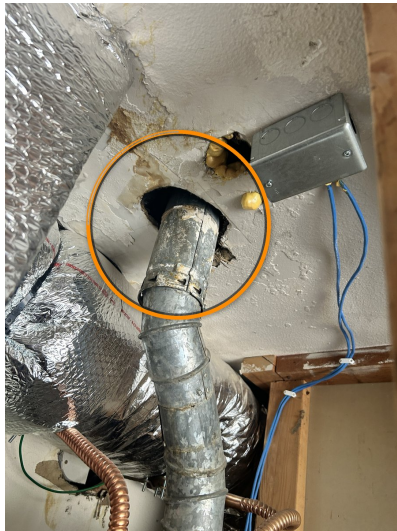
6.3 Water Heater Exhaust Vent

The vent pipe for the water heater passed through the ceiling without a visible fire stop or heat collar – this condition may reduce fire resistance and compromise safe venting – I recommend having a qualified HVAC or plumbing contractor evaluate and install a proper fire stop or thimble as needed

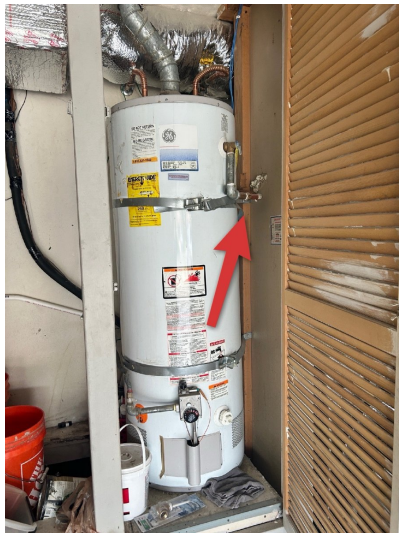
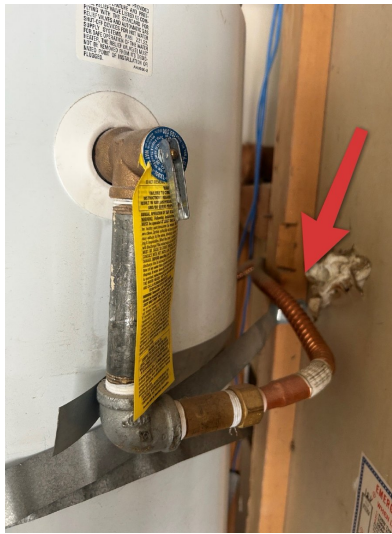
The discharge pipe had an improper slope – this condition may result in inadequate drainage, potential blockage, or damage to the pipe over time – I recommend correction by a qualified plumbing contractor

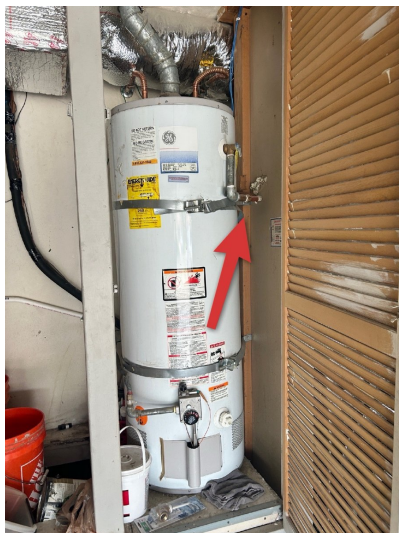
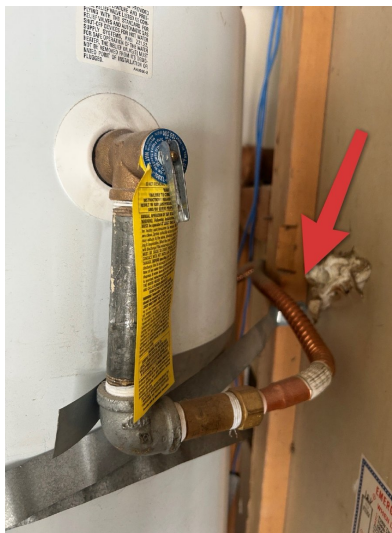
6.4.2 Reduced Pipe

The discharge pipe was reduced in diameter at one or more points – this condition may restrict proper flow and affect system performance – I recommend having a qualified plumbing contractor evaluate and correct the piping as needed to ensure proper discharge capacity

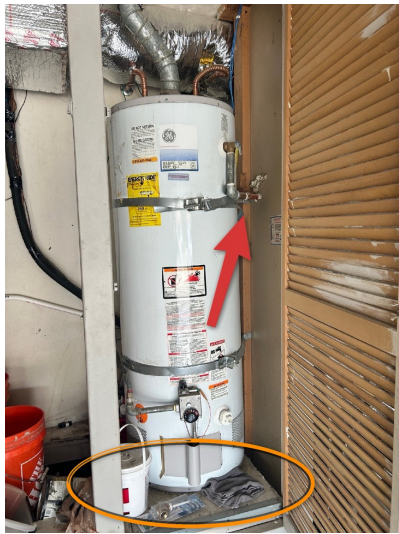
There was no catch pan installed beneath the water heater – although not always required at the time of installation, the absence of a catch pan may increase the risk of water damage to surrounding areas in the event of a leak or tank failure – I recommend installing a catch pan during the next water heater replacement to help protect the surrounding structure

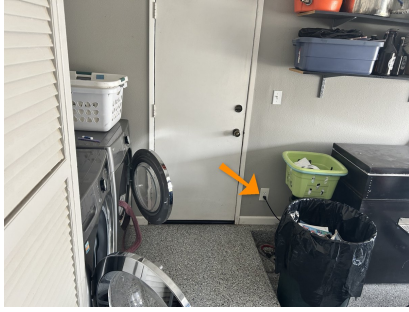
Location: Garage North

I observed that one or more outlets in the garage were not GFCI-protected, although other outlets were – this condition reduces electrical safety for the unprotected outlets – I recommend consulting a qualified electrical contractor to evaluate and consider upgrading this outlet with GFCI protection to enhance safety

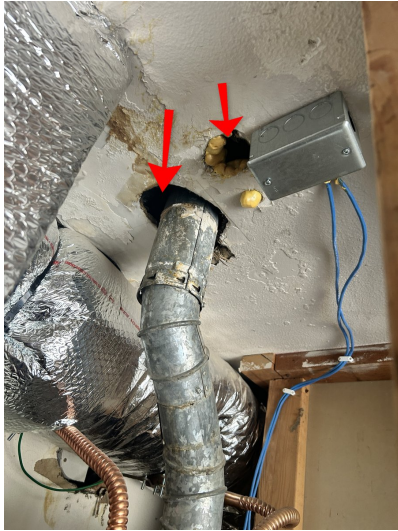
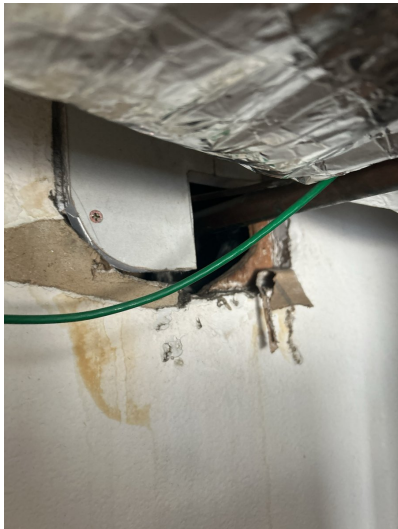
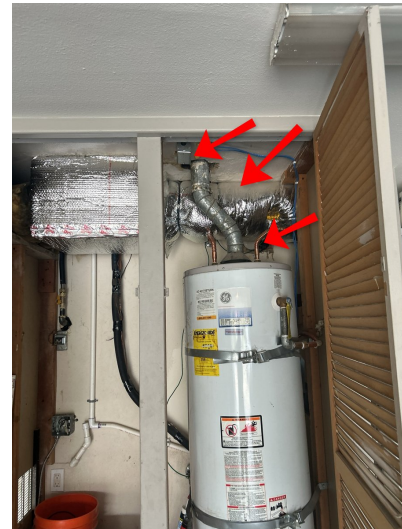
The fire separation system was damaged in one or more areas – this condition may compromise its effectiveness in limiting fire spread – I recommend correction by a qualified drywall contractor

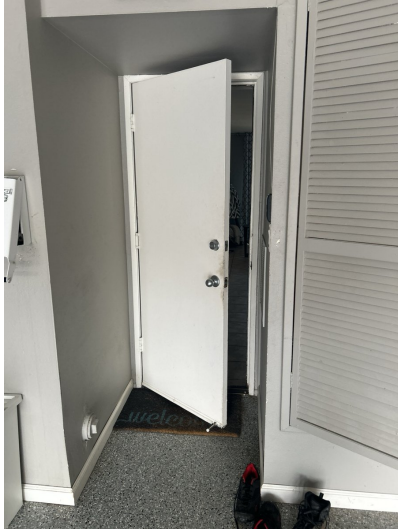
The fire door rating label was either painted over or not visible – without a legible label, I was unable to verify the fire rating or confirm whether the door meets fire separation requirements – I disclaim determining if this is a properly rated fire door – I recommend consulting a qualified contractor or the manufacturer to evaluate and confirm the door's fire rating and compliance with applicable standards

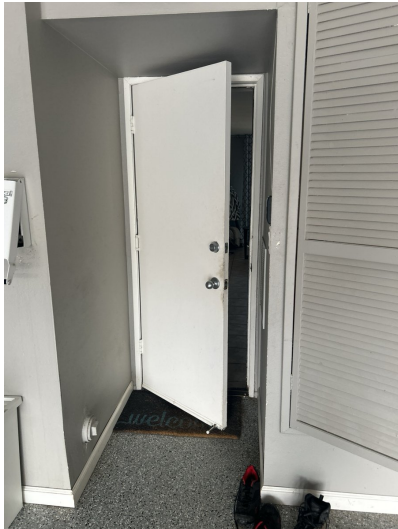
7.4.2 Did not Self-Close and Latch

The fire door did not self-close and latch, which is an important safety feature to help contain fire and smoke in an emergency – this condition may reduce the door's effectiveness in providing a barrier during a fire event – I recommend further evaluation and any necessary corrective action be performed by a qualified door contractor

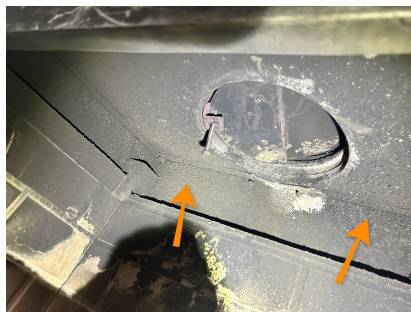
There was creosote buildup in the fireplace – this condition may reduce draft efficiency and increase the heat within the fireplace to unsafe levels over time – I recommend consulting a qualified chimney sweep to clean the fireplace and chimney and evaluate for any additional concerns

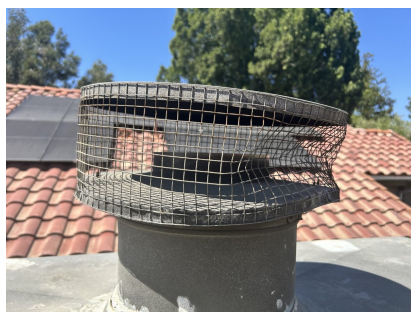
The chimney cap was dented but did not appear to affect performance – this condition was cosmetic and did not impact its ability to protect the flue from moisture and debris – I recommend monitoring for any future deterioration and replacing the cap if functional issues develop

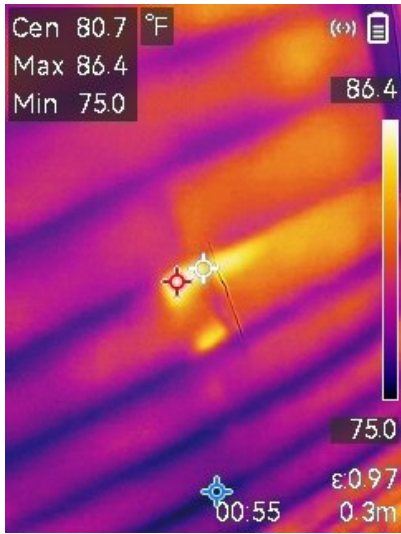
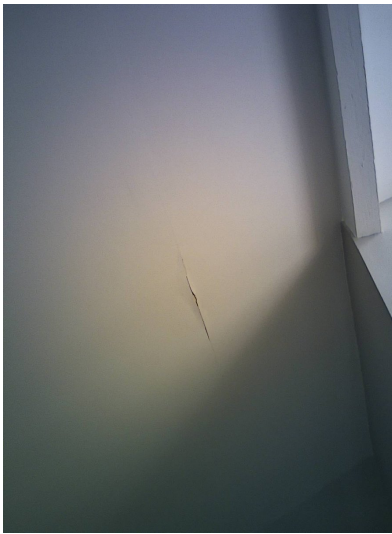
There was evidence of past moisture problems, which may conceal hidden defects – I recommend consulting with the seller and reviewing disclosures for any past history of moisture issues – further evaluation and repair by a qualified general contractor are also recommended as needed

Location: 1st Floor Living Room Dining Room

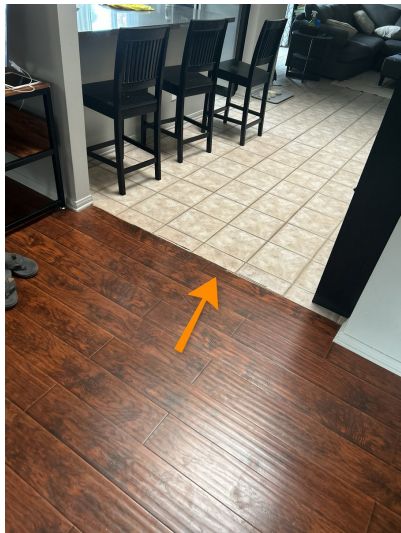
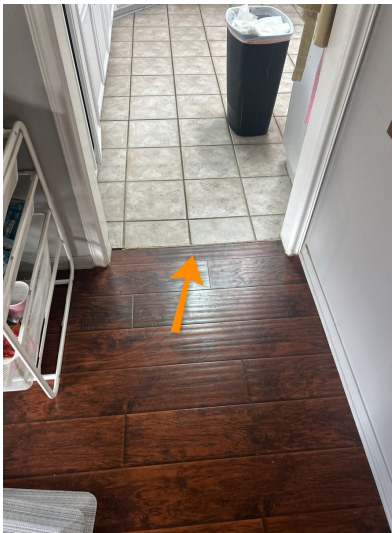
Floor transitions were missing at one or more locations as indicated – this condition may affect the appearance and usability of the flooring and could create uneven surfaces – I recommend installing appropriate transitions by a qualified flooring contractor

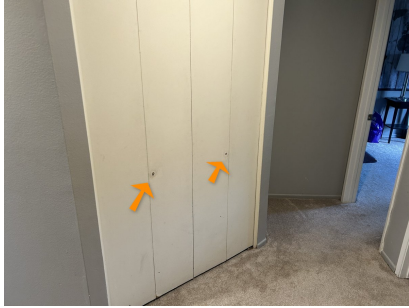
Location: 2nd Floor Hall

The closet door was missing a door knob – this condition may impede ease of use and access to the closet – I recommend installing a door knob by a qualified door contractor

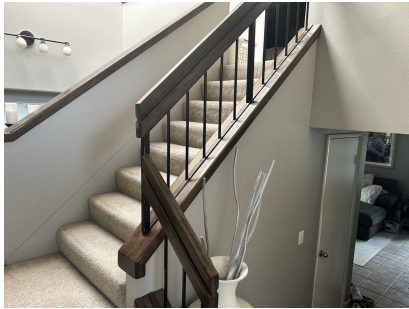
Openings between balusters, beneath, or at the sides of the handrails appeared wide enough that a small child's head may fit through – this condition may pose a safety concern – I recommend correction by a qualified carpenter or general contractor to improve safety

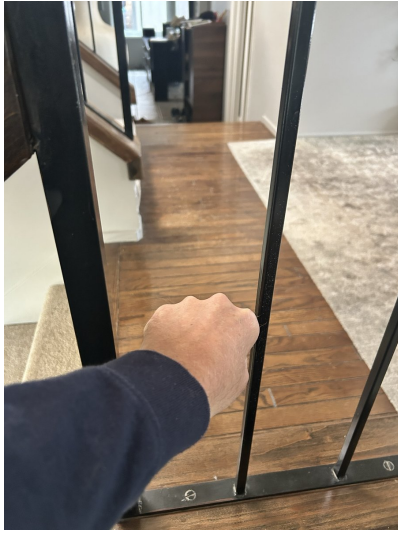
Openings between balusters, beneath, or at the sides of the guardrails appeared wide enough that a small child's head may fit through – this condition may pose a safety concern – I recommend correction by a qualified carpenter or general contractor to improve safety

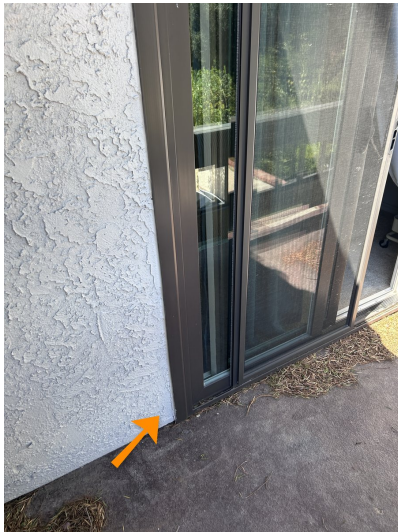
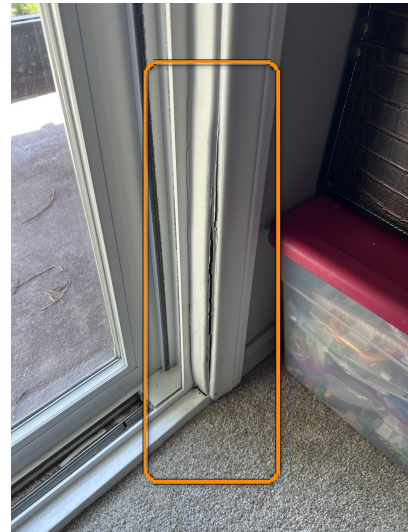
Moisture damage was apparent at the time of the inspection and/or there was evidence of past moisture intrusion, which may conceal defects – I recommend consulting with the seller and reviewing disclosures for any information on past moisture issues, and having a qualified contractor evaluate and repair as needed

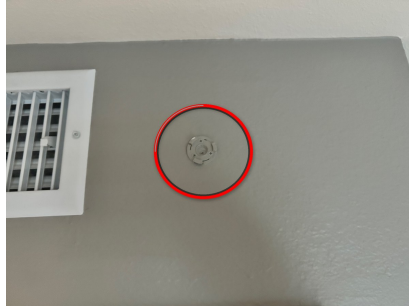
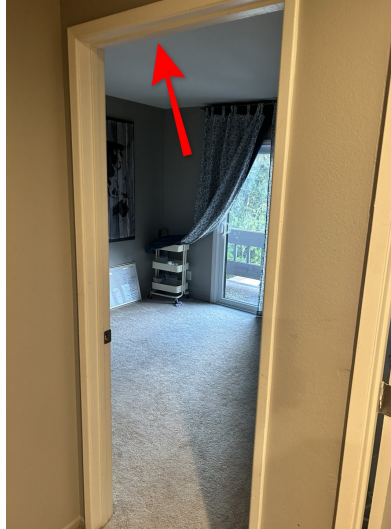
Location: 2nd Floor Den

The smoke detector was missing at the time of the inspection – missing smoke detectors significantly increase the risk of undetected fire and potential harm to occupants – I recommend installation of a smoke detector by a qualified technician to enhance safety

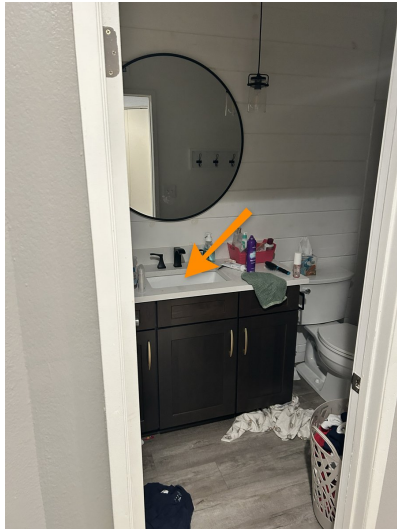
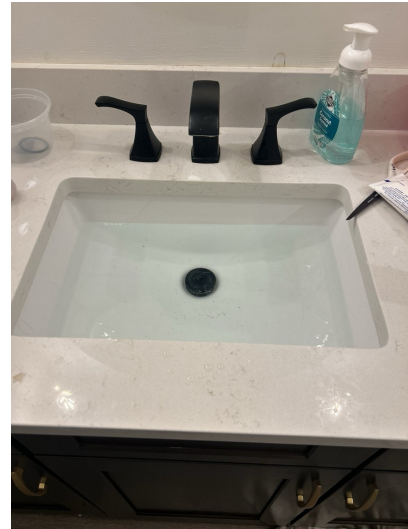
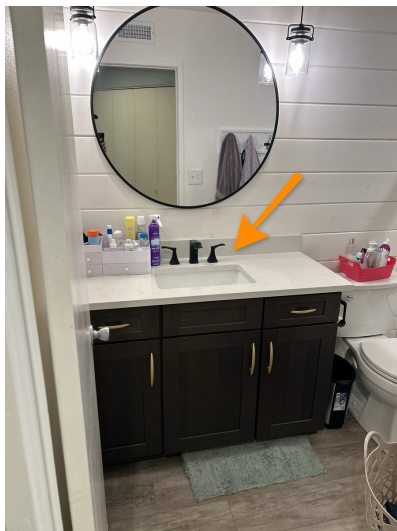
The sink was slow to drain – this condition may indicate a partial blockage or buildup within the drain line – I recommend having the blockage located and cleared by a qualified plumbing contractor

Location: 2nd Floor Hall Primary

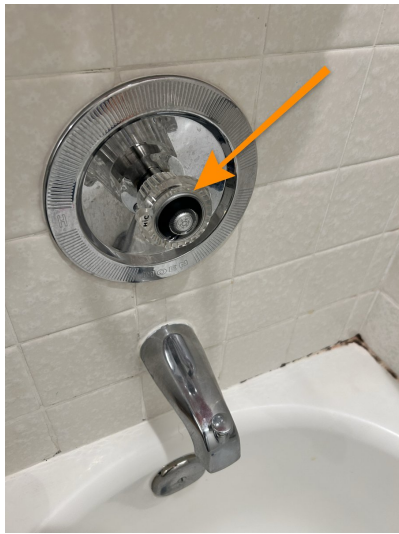
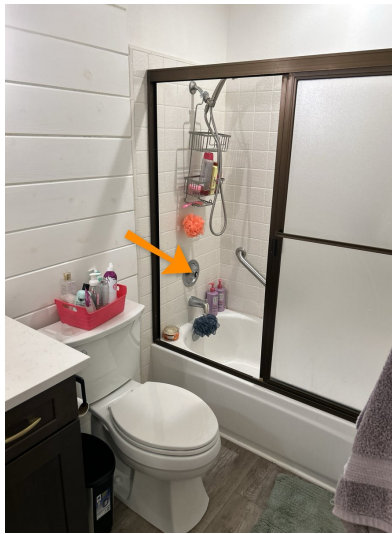
Hot and cold water supply connections were reversed at this bathtub – this condition could lead to unintended scalding and inconvenience during use – I recommend having the connections corrected by a qualified plumbing contractor to improve safety and functionality

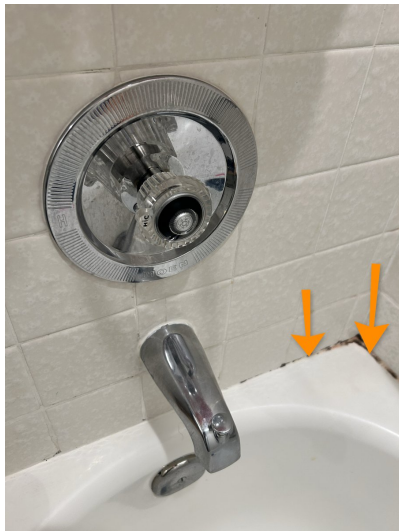
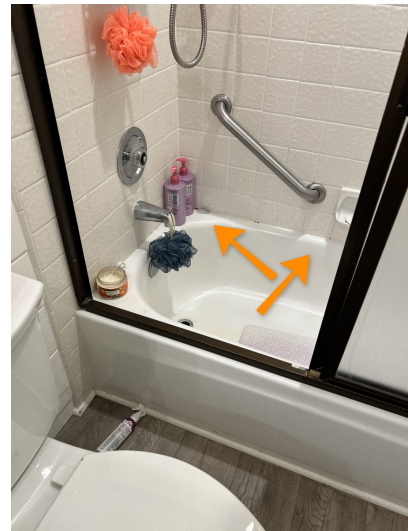
Surface microbial growth and/or irregular staining were observed on nonporous surfaces – this condition may indicate elevated moisture levels and could lead to material deterioration if left unaddressed – I recommend cleaning and sealing the materials regularly to maintain their condition

Location: 2nd Floor Hall Bathroom

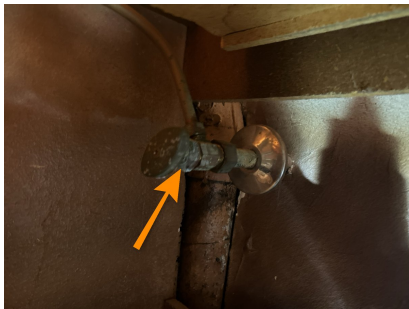
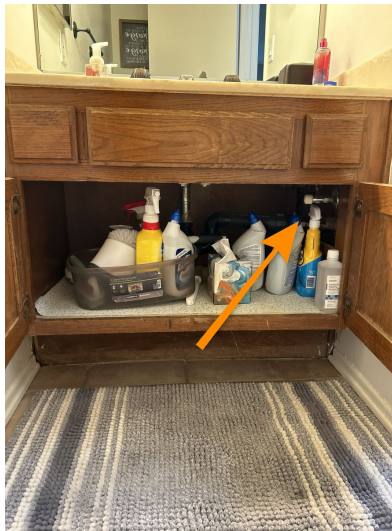
12.5.2 Corroded-Drain

I observed corroded drain pipes beneath the sink – this condition increases the risk of leaks, which could damage the cabinet floor and potentially the adjacent wall or floor structures – I recommend replacement by a qualified plumbing contractor to mitigate these risks

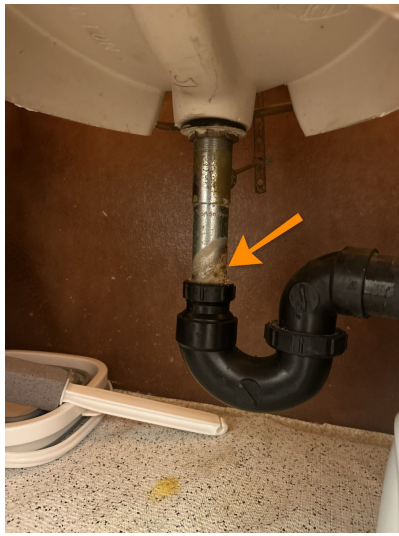
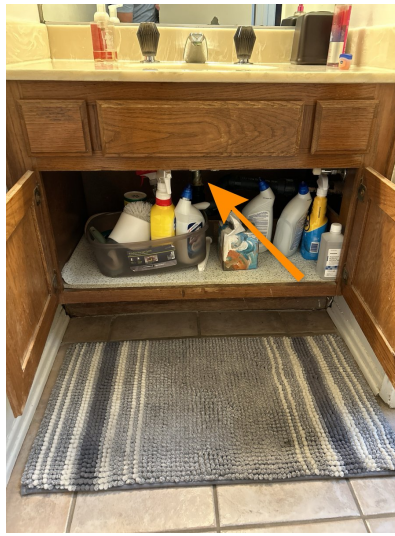
Location: 1st Floor Half Bath

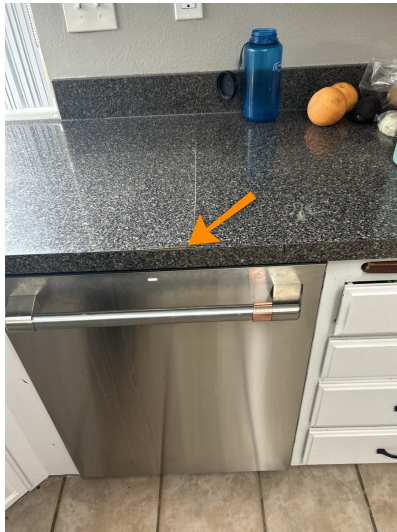
The counter exhibited areas of blistering – this condition may detract from its appearance and compromise its long-term durability – I recommend further evaluation and repair by a qualified carpenter or countertop specialist to restore its functionality and aesthetics

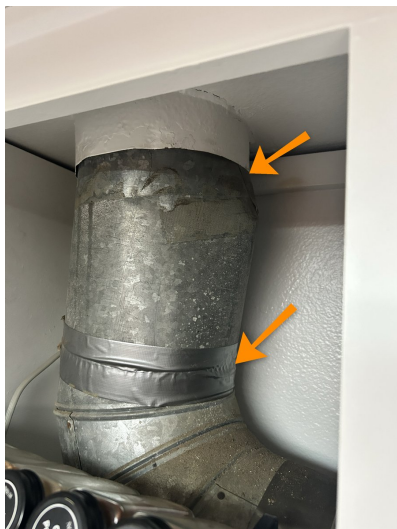
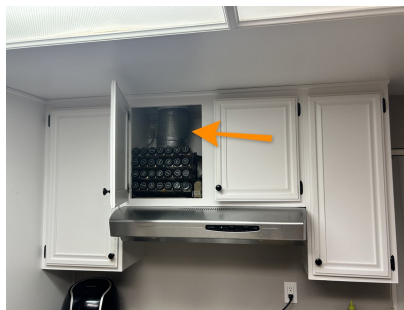
13.2.1 Improper Tape

There was improper tape used at the kitchen exhaust vent duct connections – this condition may result in deteriorated seals over time, potentially compromising the vent's performance – I recommend replacing the tape with foil or heat-resistant tape by a qualified appliance technician

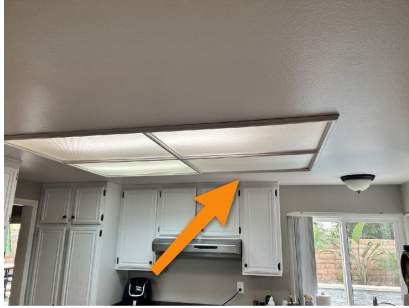
13.3.1 Defective Bulb

One or more light bulbs were not operational at the time of the inspection – I recommend replacing the bulbs to determine if the issue is related to the bulb itself – if the lights still do not operate, I recommend further evaluation and any necessary corrective action be performed by a qualified electrical contractor

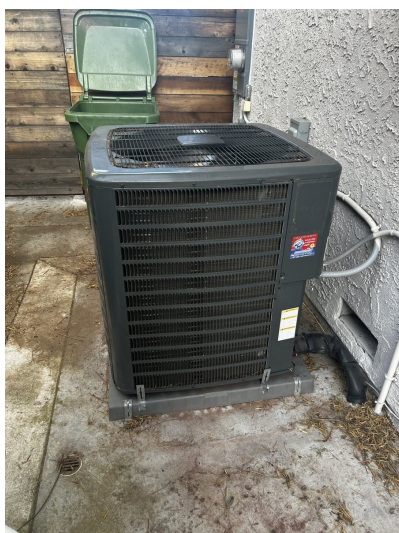
15.1.5 Location: Exterior North

15.1.4 Brand: Goodman

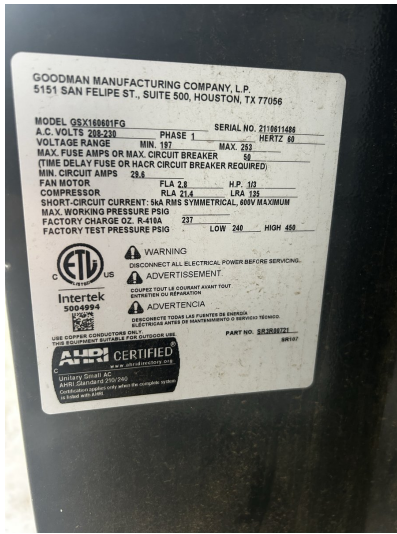
15.1.6 AC Compressor Manufacturer Year

The industry average service design life of most forced air furnaces is 15-20 years, and the industry average service life for most air conditioning condensing units is 10-15 years. Routine upkeep/maintenance, regional weather/climate, and location/placement of the system will play a critical roles in the longevity of these systems

2021

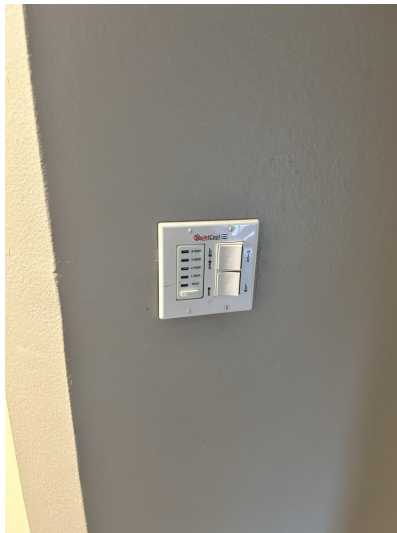
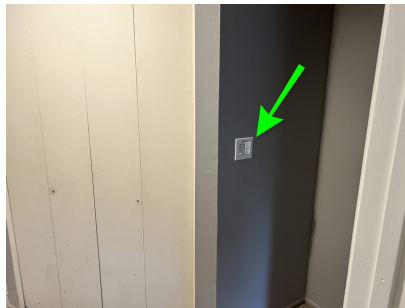
Location: 2nd Floor Hall

The Whole House fan controls are one the east side of the upstairs hallway

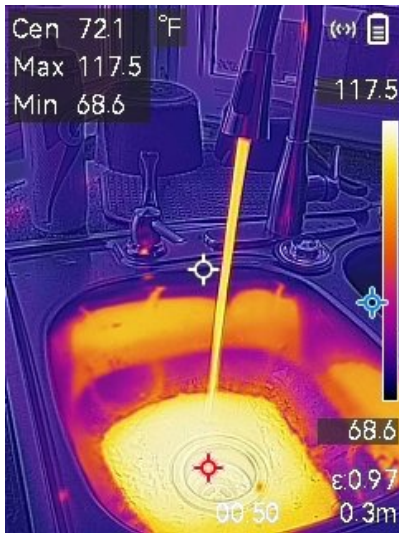
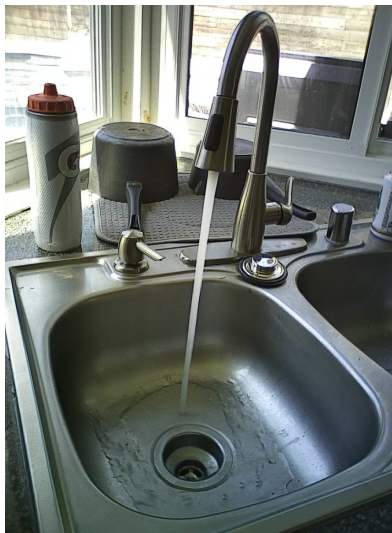
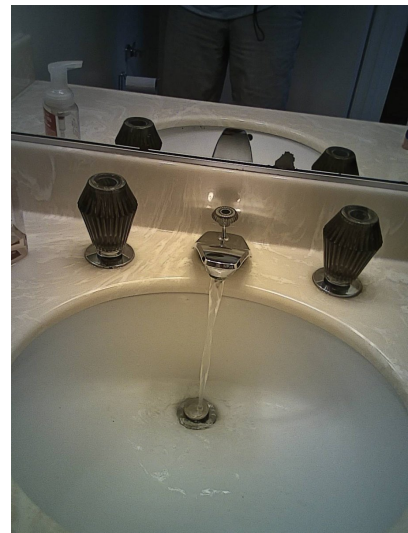
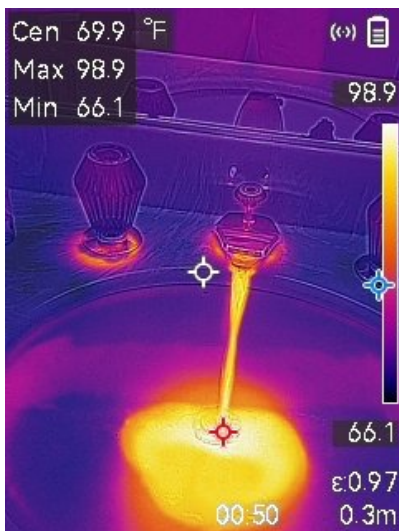
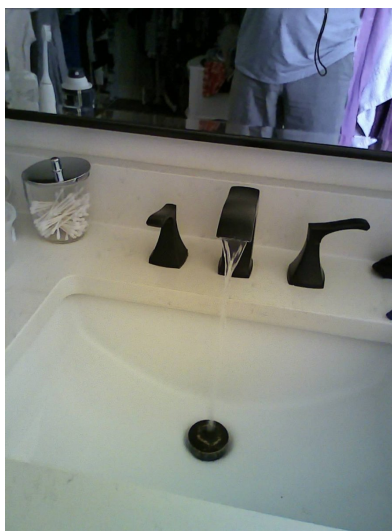
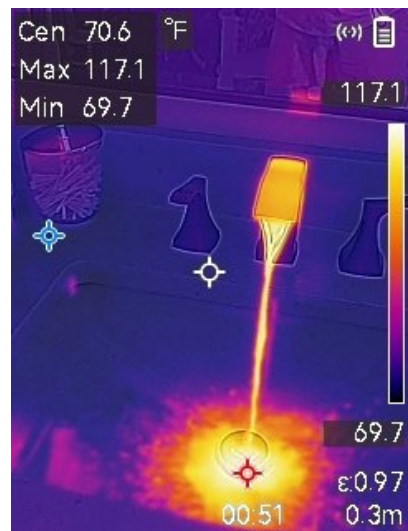
21.1.2 Thermal Images

Thermal imaging was used to assist in identifying potential concerns but does not guarantee the absence of issues – areas of concern should be further evaluated by qualified contractors or specialists as necessary.

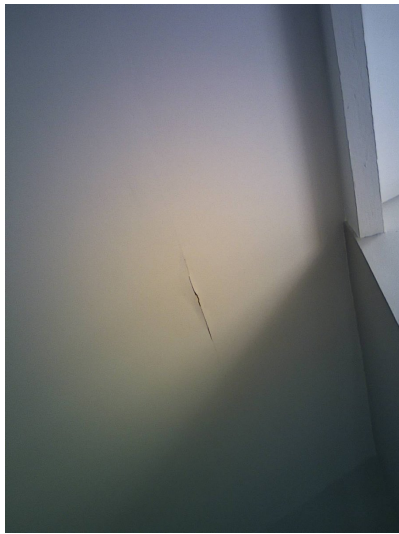
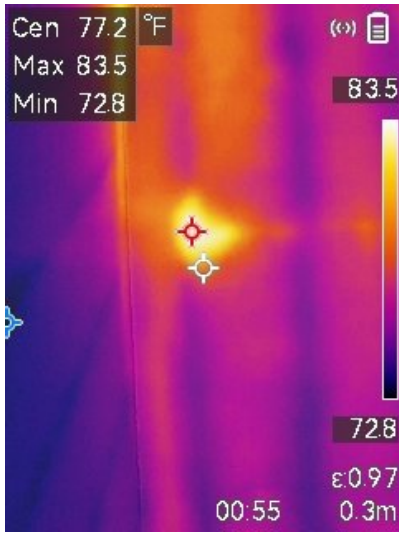
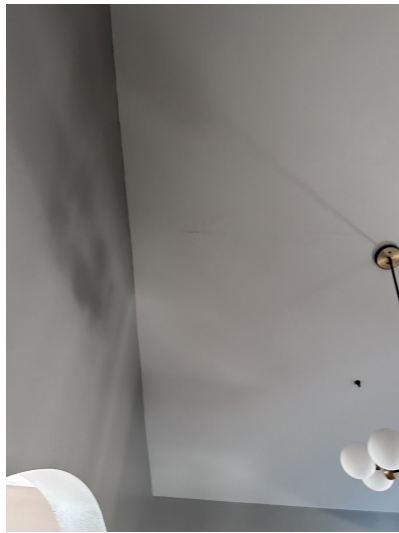
21.1.3 Ceiling Voids

Location: 1st Floor Dining Room Living Room

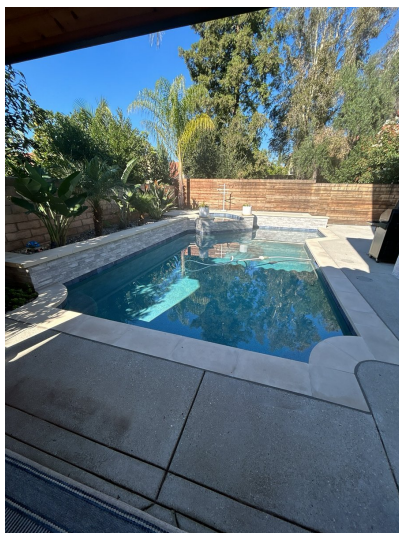
22.1.3 Pool/Spa View

22.1.2 Type of Pool/Spa:: Inground Pool and Spa

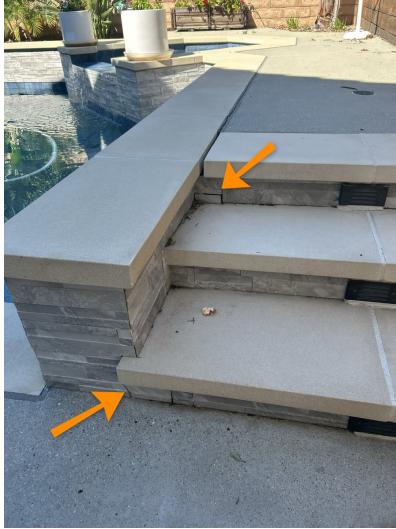
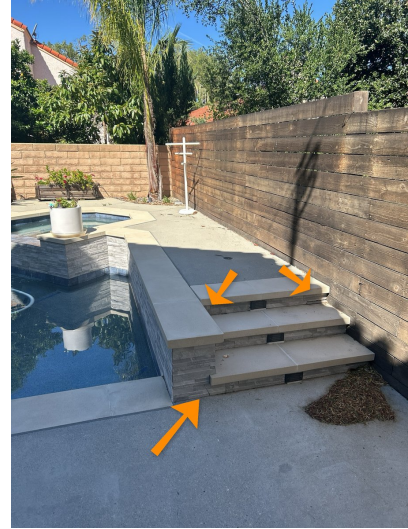
The cracked tile(s) should be evaluated and repaired as needed by a qualified pool contractor.

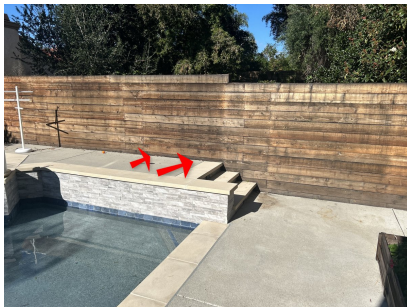
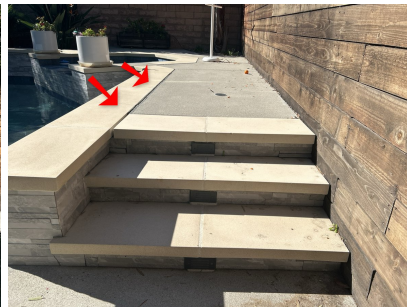
22.3.4 Decking Settling

The pool decking and steps were observed to be settling toward the fence. This condition may be due to the fact that the wooden fence was used to support the concrete steps and walkway. If no additional support is added, soil may erode and further settling may occur. I recommend evaluation by a qualified pool contractor.

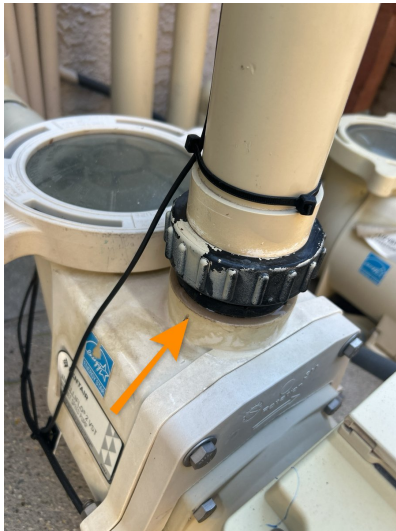
A leak was observed at the connector to the main filter pump. This condition could cause loss of water and deterioration of pool equipment. I recommend this leak be evaluated by a qualified pool contractor.

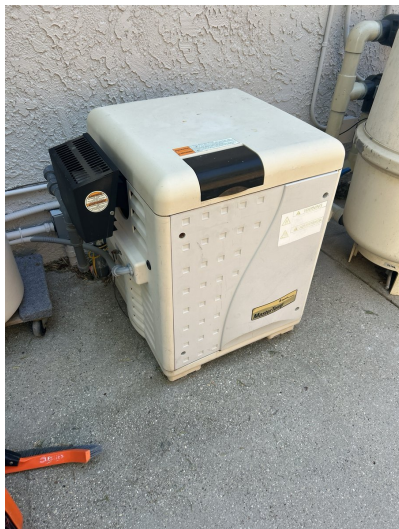
22.11.1 Serviceable

The heater was operational at the time of our inspection unless otherwise noted.

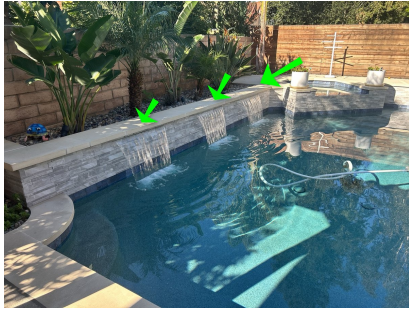
22.12.1 No Wall Diving

The raised wall above the pool surface is not designed for diving as the pool depth may not be adequate. These areas should be monitored to prevent injury.

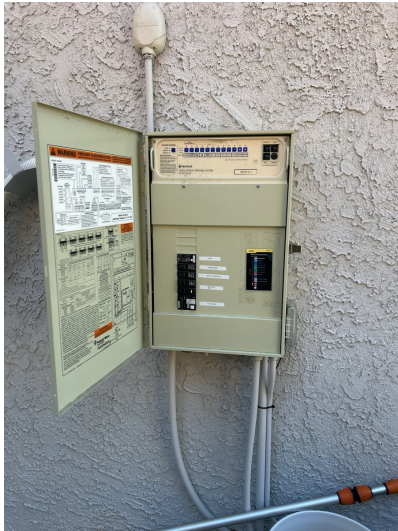
22.13.2 Circuit Breaker Location(s):: Equipment Area

22.13.1 Wiring Type:: Rigid Metal, Liquid Tight Conduit
